47 MLB

**Watertight Door
Maintenance
&
Adjustment**

This guide is designed to aid in the troubleshooting and adjustment of WTD's onboard the 47' MLB. This guide is not a replacement for good engineering practices, preventive maintenance manuals and manufactures technical manuals.

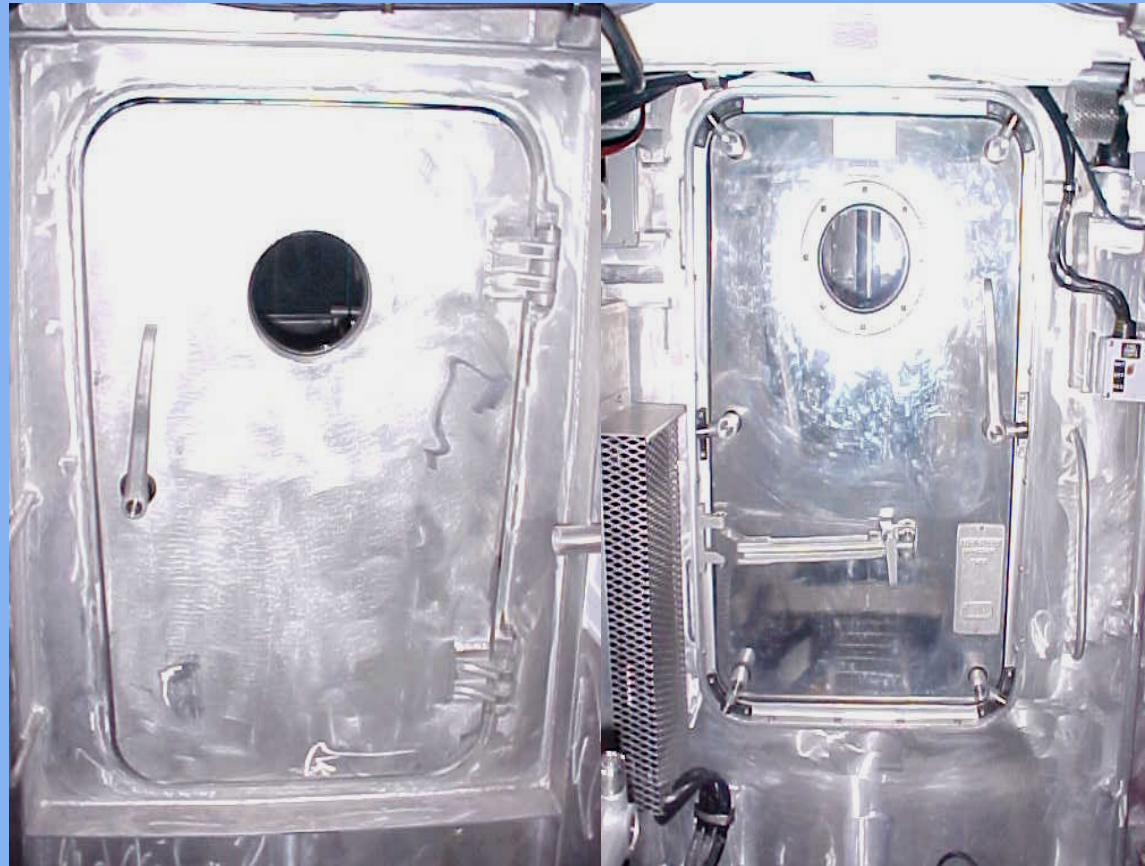
Auxiliary Machine Space

- F/N - 010
- 24X40, 90lbs
- 6 dogging points
- Quick acting
- Hinged
- Vertical
- Door hold open arm
- Opens fwd
- Round window

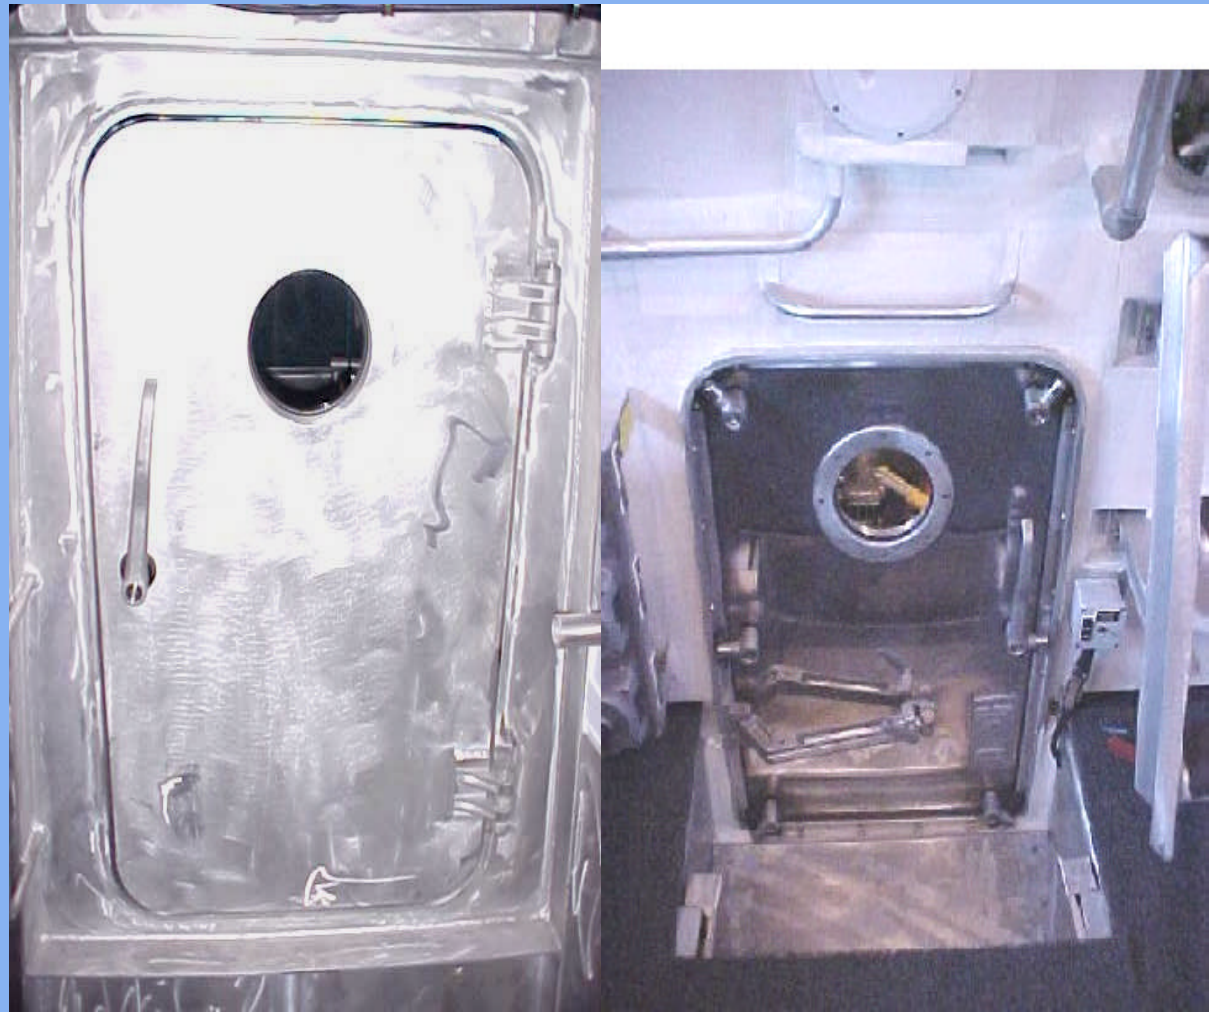
Engine Room Watertight Door

- F/N - 009
- 24x40, 88lbs
- 6 dogging points
- Quick acting
- Hinged
- Vertical
- Gas Shock
- Opens fwd
- Rectangular window
- Gas spring 825 PSI charge

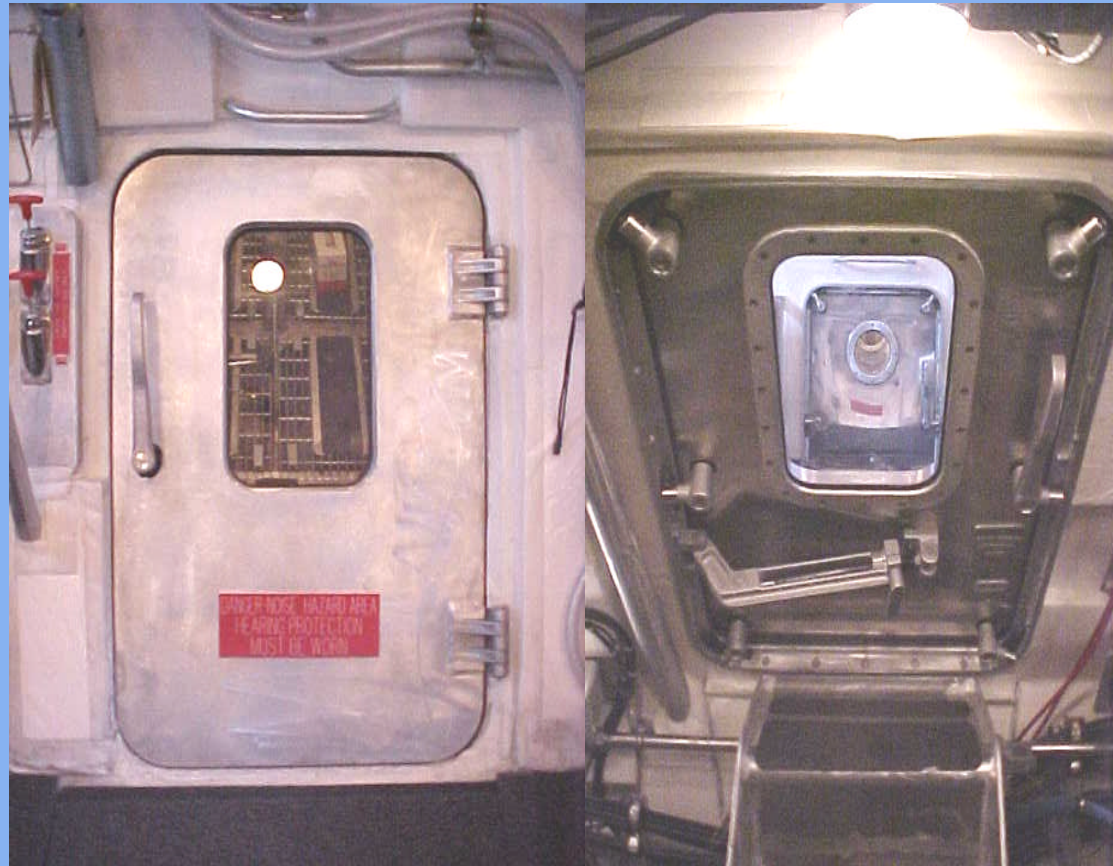
Lazarette Watertight Door

- F/N - 012
- 24x32, 77lbs
- 4 dogging points
- Quick acting
- Hinged
- Vertical
- Door hold open arm
- Opens fwd
- Round window

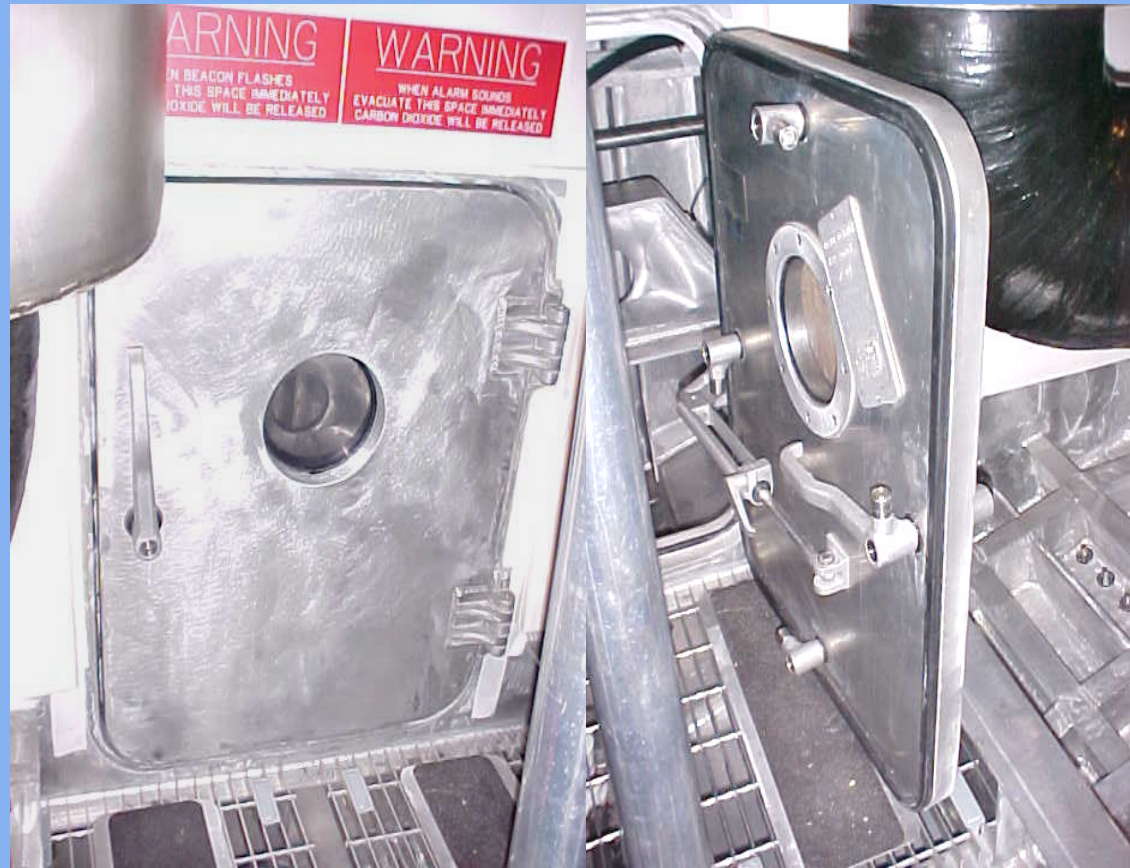
Aft Deck to Survivors Compartment Watertight Door

- F/N - 008
- 28x54, 115lbs
- 6 dogging points
- Quick acting
- Hinged
- Vertical
- Gas shock
- Opens aft
- Round window
- Gas spring 1200 PSI charge

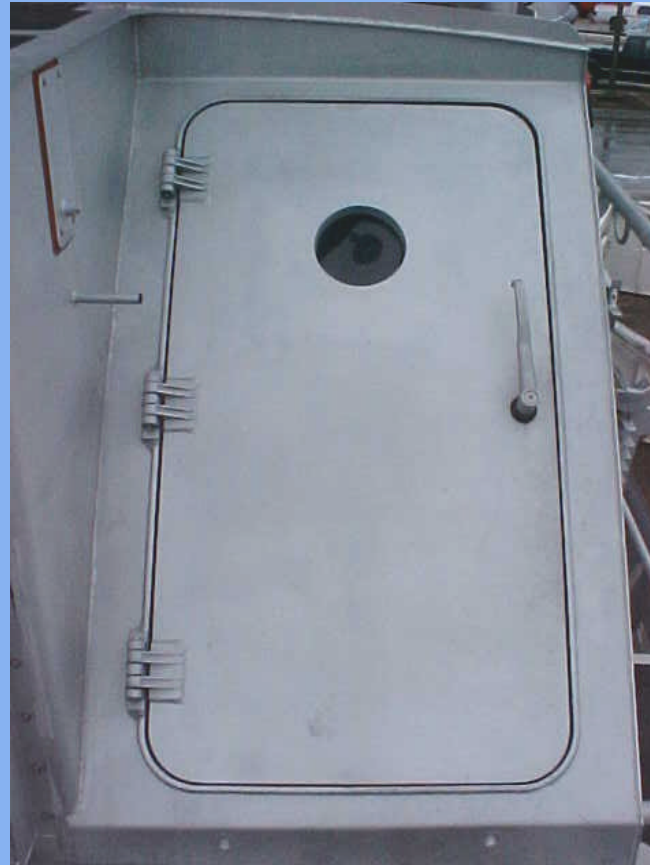
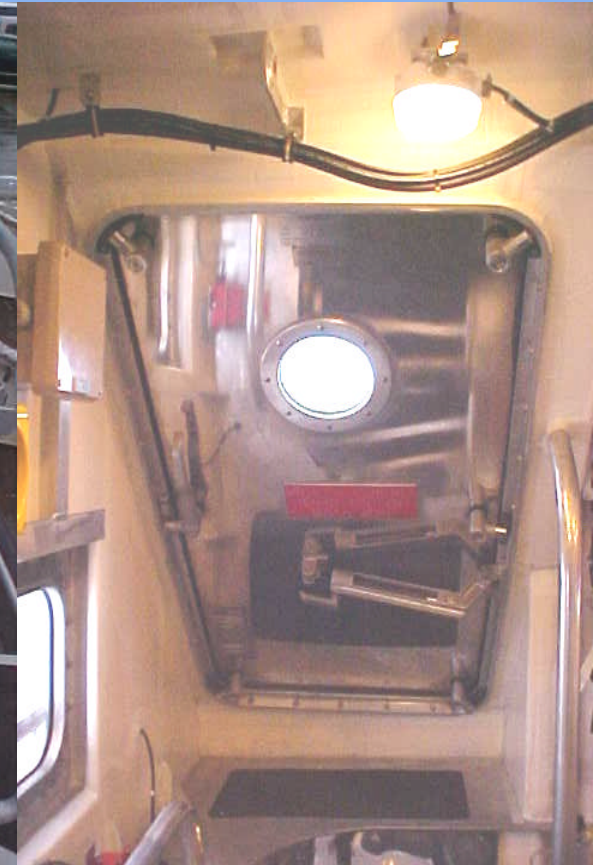
Open Bridge Watertight Door

- F/N - 007
- 24x40, 93 lbs
- 6 dogging points
- Quick acting
- Hinged
- Vertical
- Gas shock
- Opens aft
- Rectangular window
- Gas spring 400 PSI charge

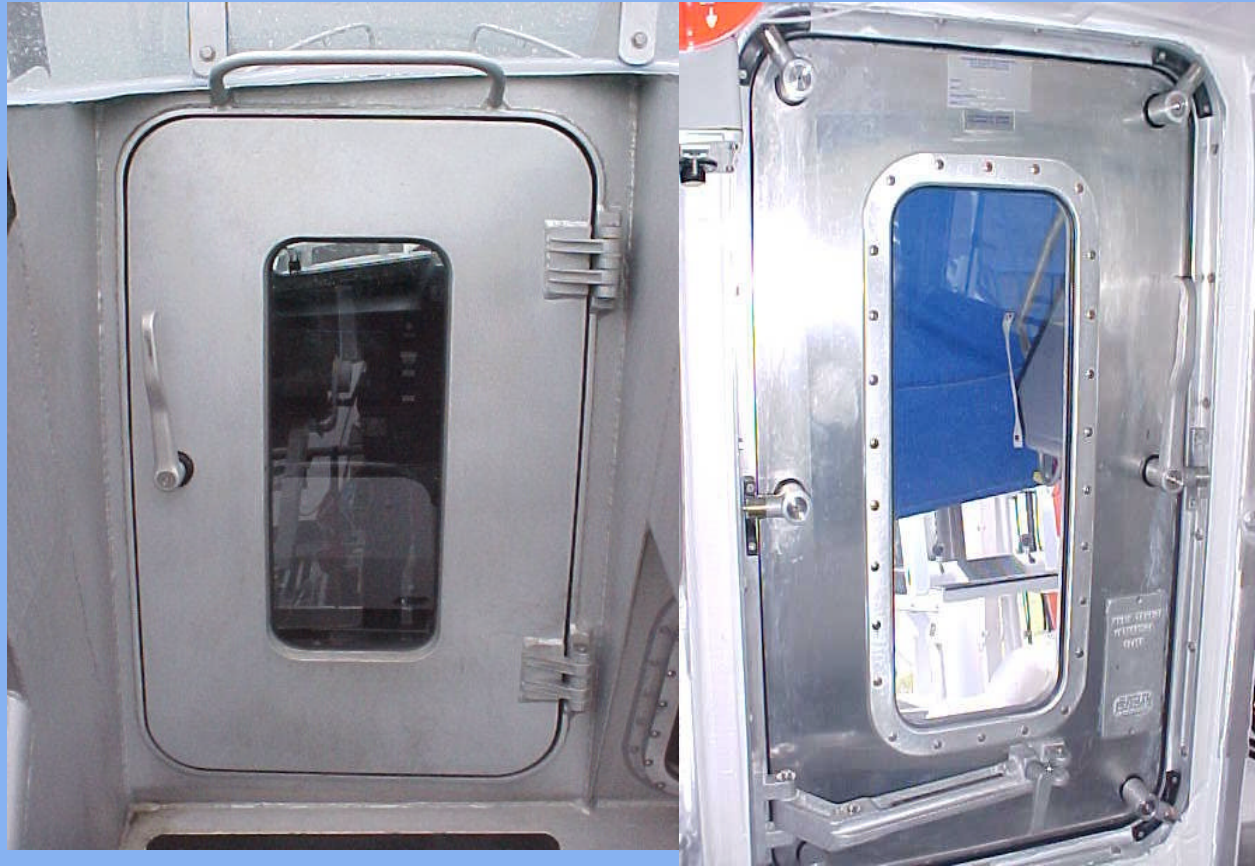
Enclosed Bridge Watertight Door

- F/N - 011
- 24x40, 91lbs
- 6 dogging points
- Quick acting
- Hinged
- Vertical
- Gas shock
- Opens fwd
- Two round window
- Gas spring 400 PSI charge

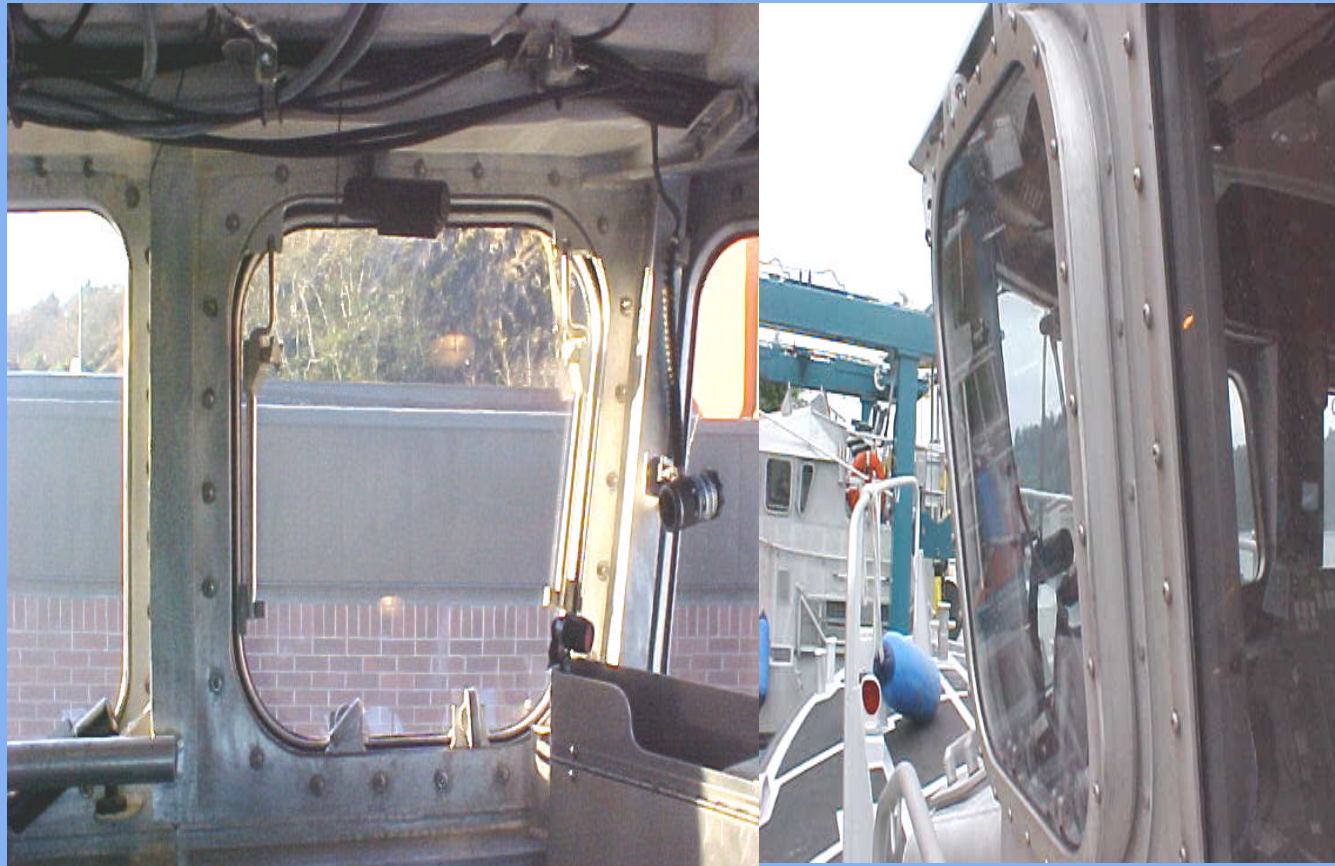
Port and Stbd EWRS Windows

- 13X22,
18LBS
- 1 Dogging
point
- Hinged
- Pneumatic
actuated

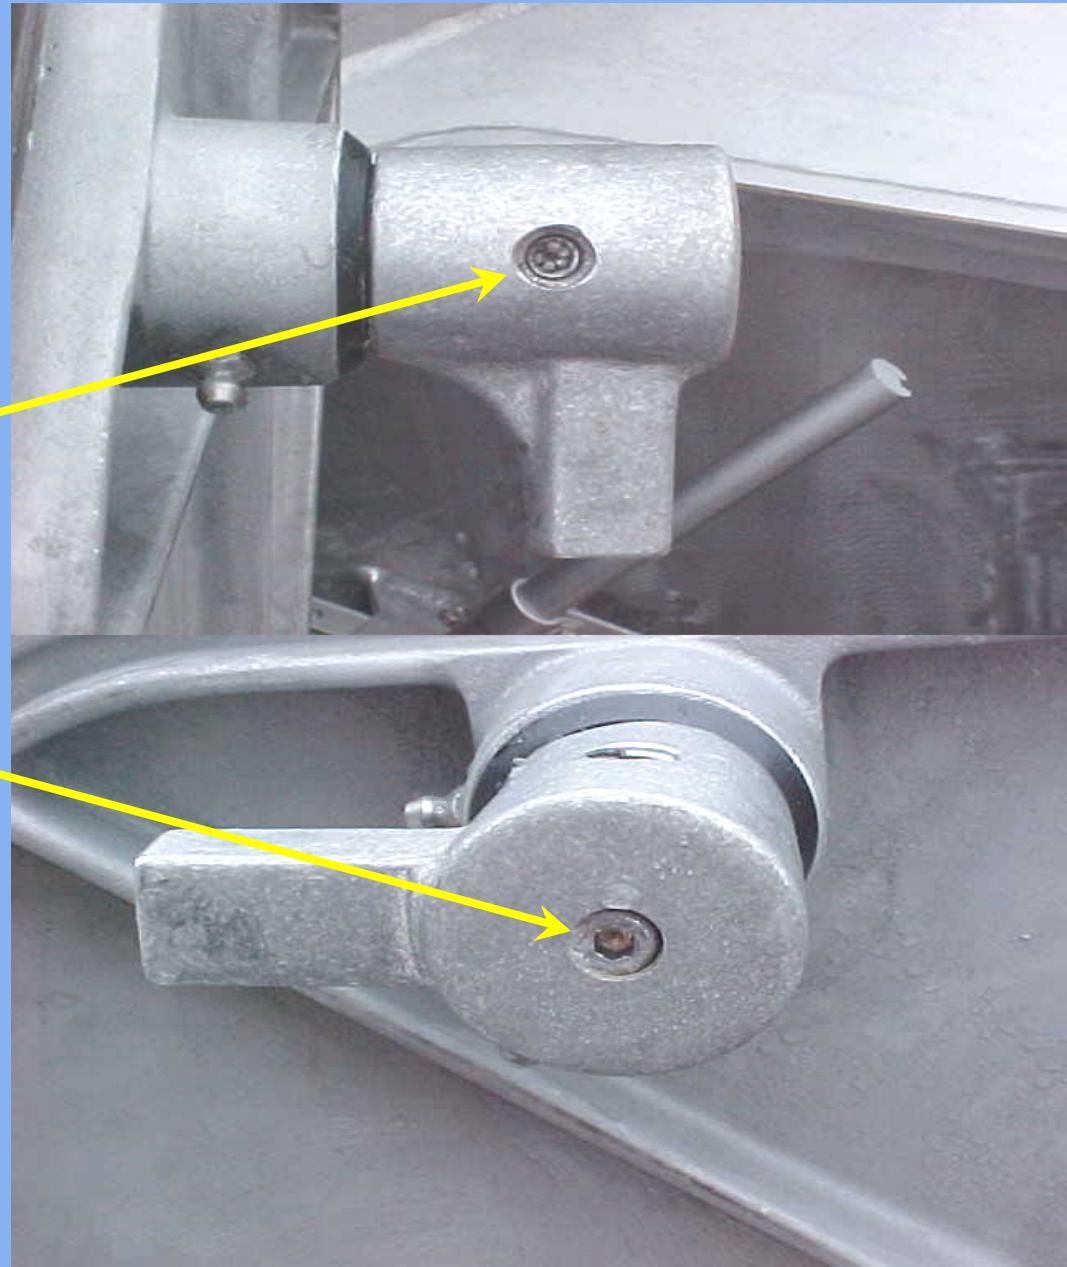
Forward Deck Locker

Failure to seal Hinge side of hatch.

- 1.) Remove hinge bolt and verify its straightness.
- 2.) Replace bolt if in doubt.
- 3.) Recheck for seal.

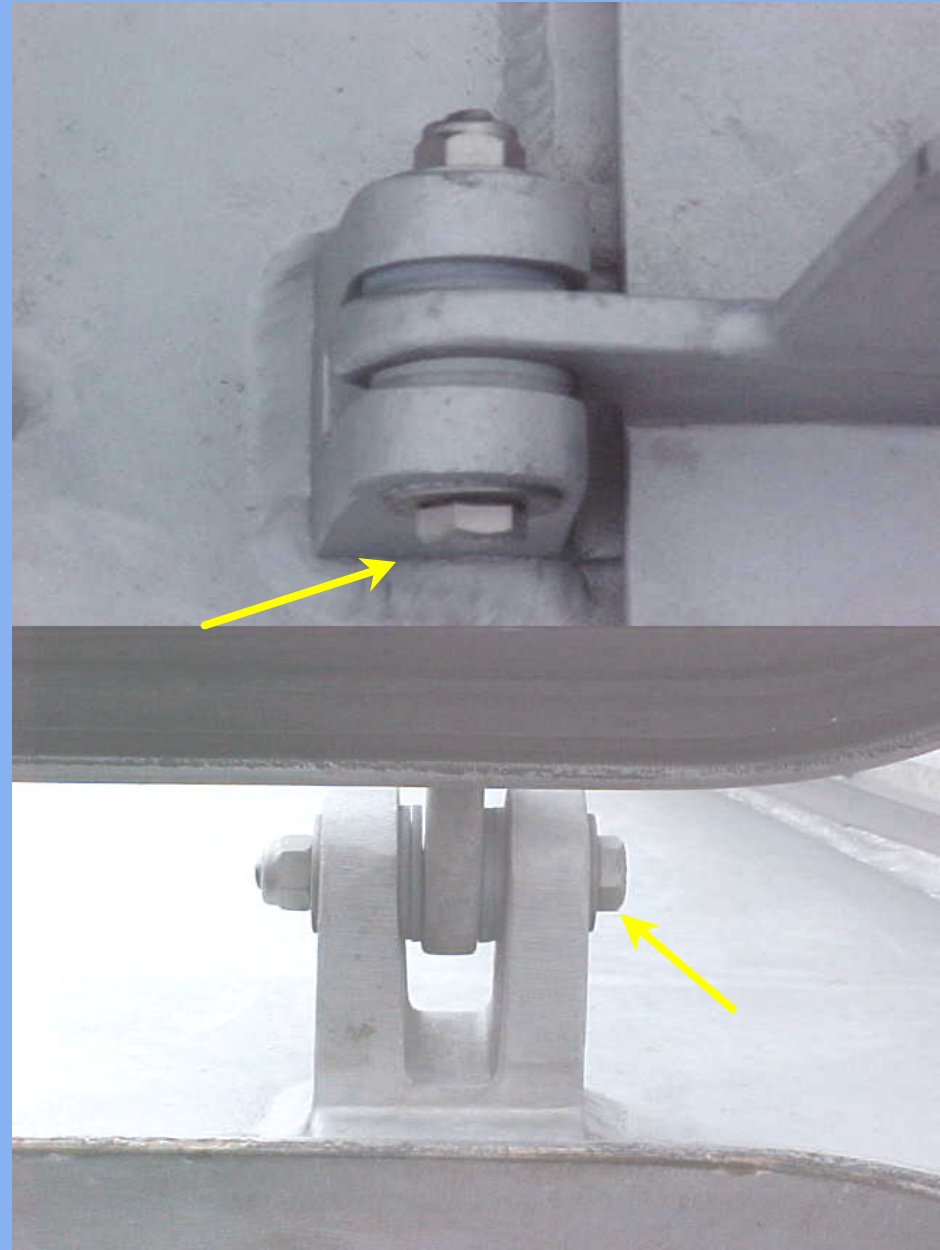
General Maintenance for Forward Deck Locker

- 1.) Check knife edge for defects or damage, repair as necessary.

Note: Your MLB may be equipped with non-Freeman cast knife edge, which will have surface defects and distortions due to manufacturing and installation.

- 2.) Check knife edge for twist or warp, replace knife edge if found.
- 3.) Check hatch for twist and warp, replace if found.
- 4.) Check condition of gasket, if knife edge has caused a permanent indentation greater than 1/8" deep, replace gasket, recheck for seal.

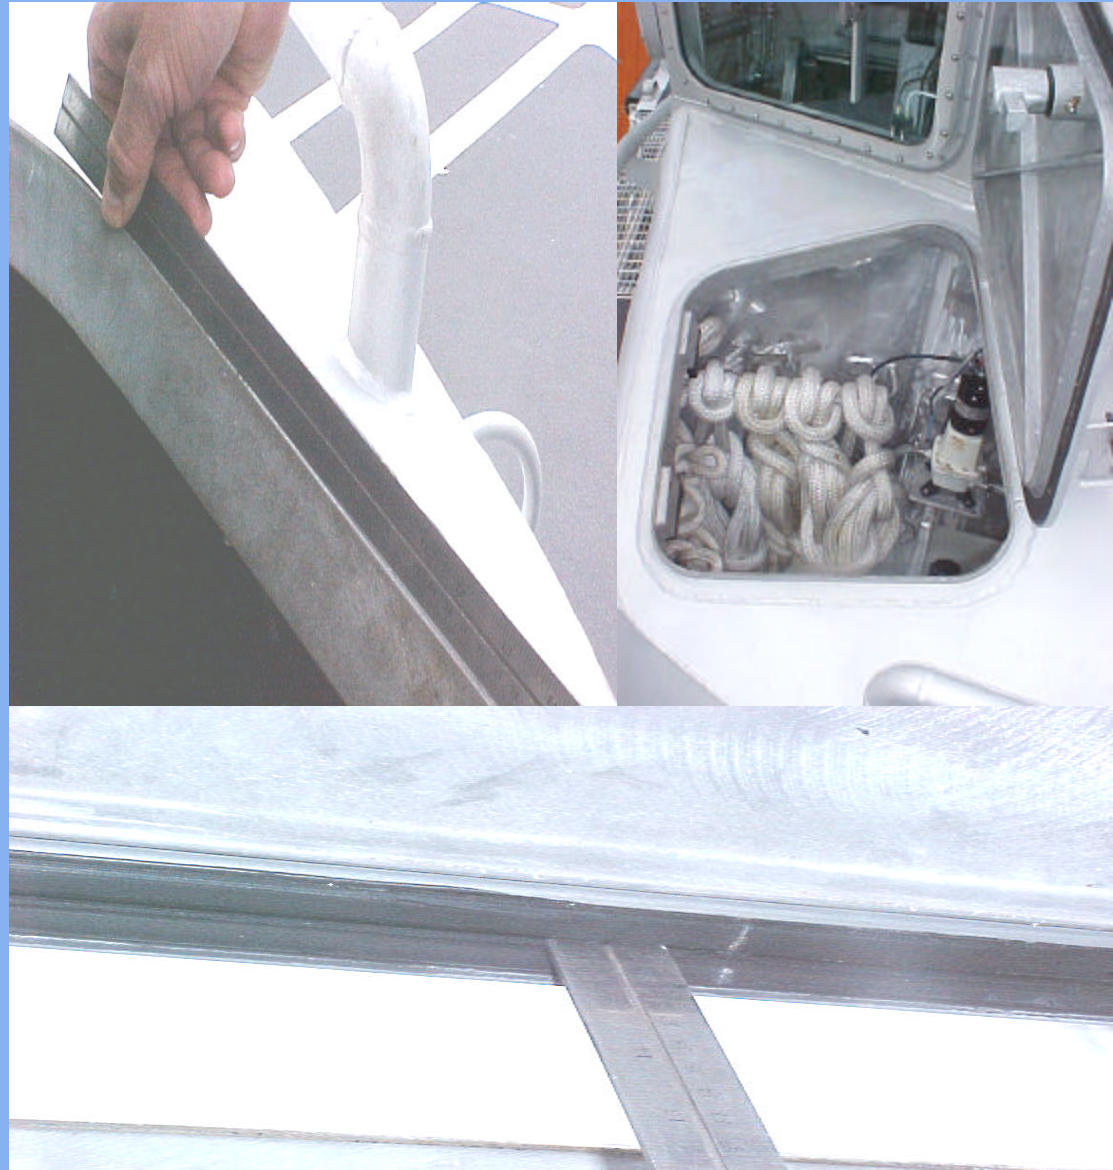
Dogs Fall off Shaft

- 1.) Remove Allen head cap screw(s) and check condition of nylon bead on the thread. If bead is worn, replace it.

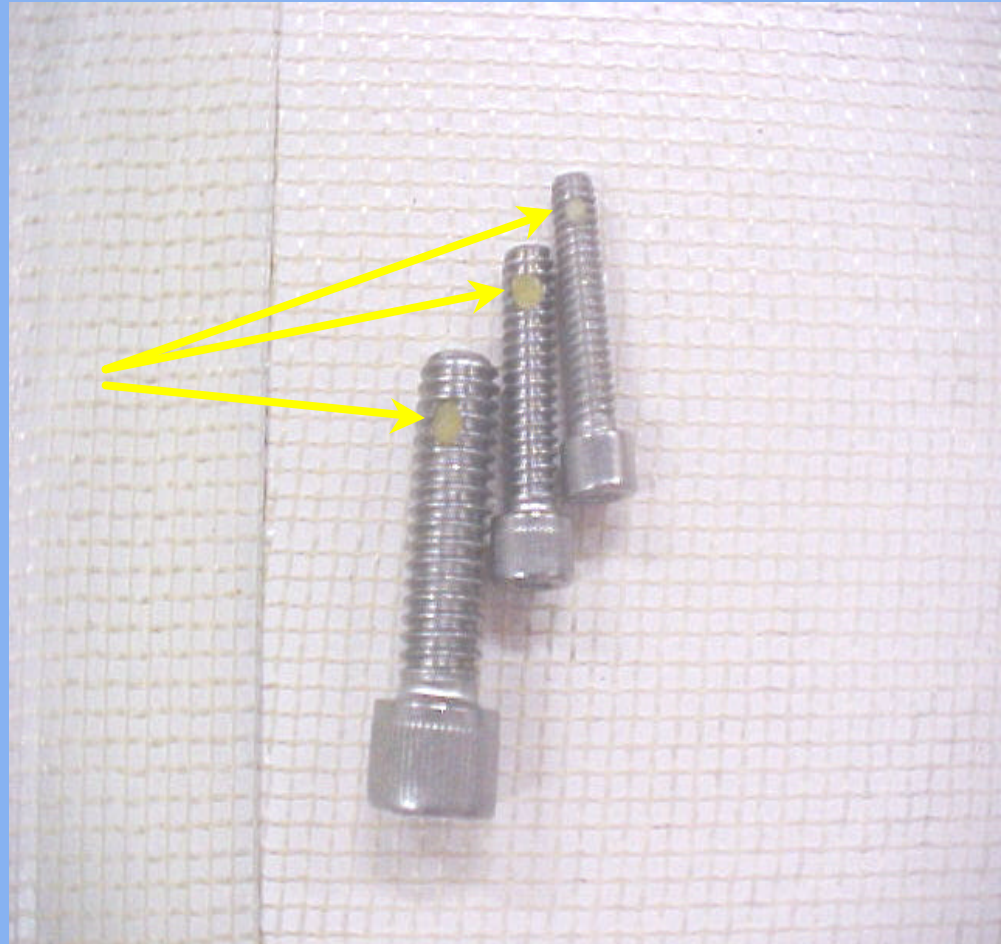
Aft Deck Buoyancy Box

Failure to seal

Handle side

- 1.) Check for loose Allen head cap screw on the end of the dog. “Do not over tighten set screws; they should be turned down just until the assembly makes light contact against the washer shims, otherwise the closure will be hard to operate”

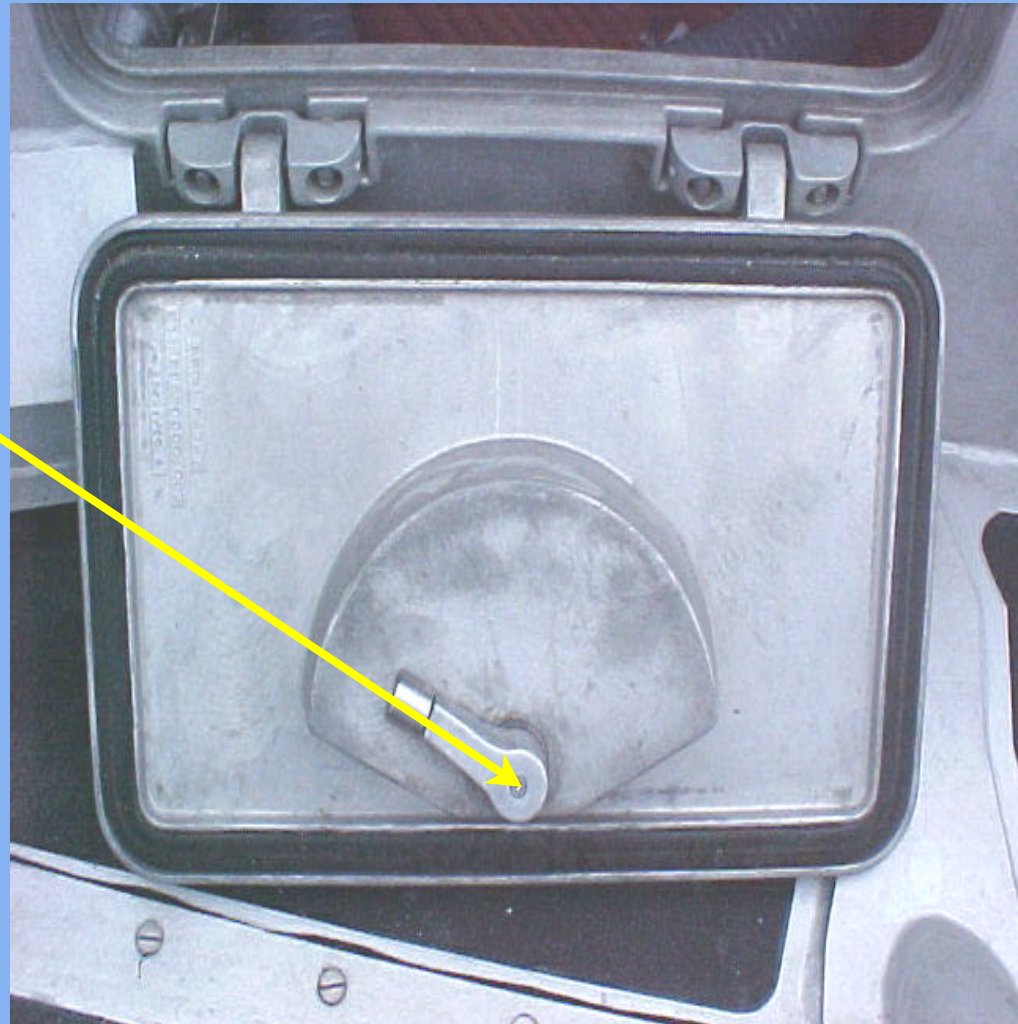
Aft Deck Buoyancy Box (Cont.)

Failure to seal hinge side

- 2.) Check hatch to see when hinge side of gasket makes contact with knife- edge. The edge of the hatch should be even with the outer edge of hatch coaming when gasket makes contact on the hinge side. When you dog the hatch, as the dog slides up the cam in the striker plate it will cause the hatch to be pulled in and the gasket will make contact with the knife edge and the hatch will seal.

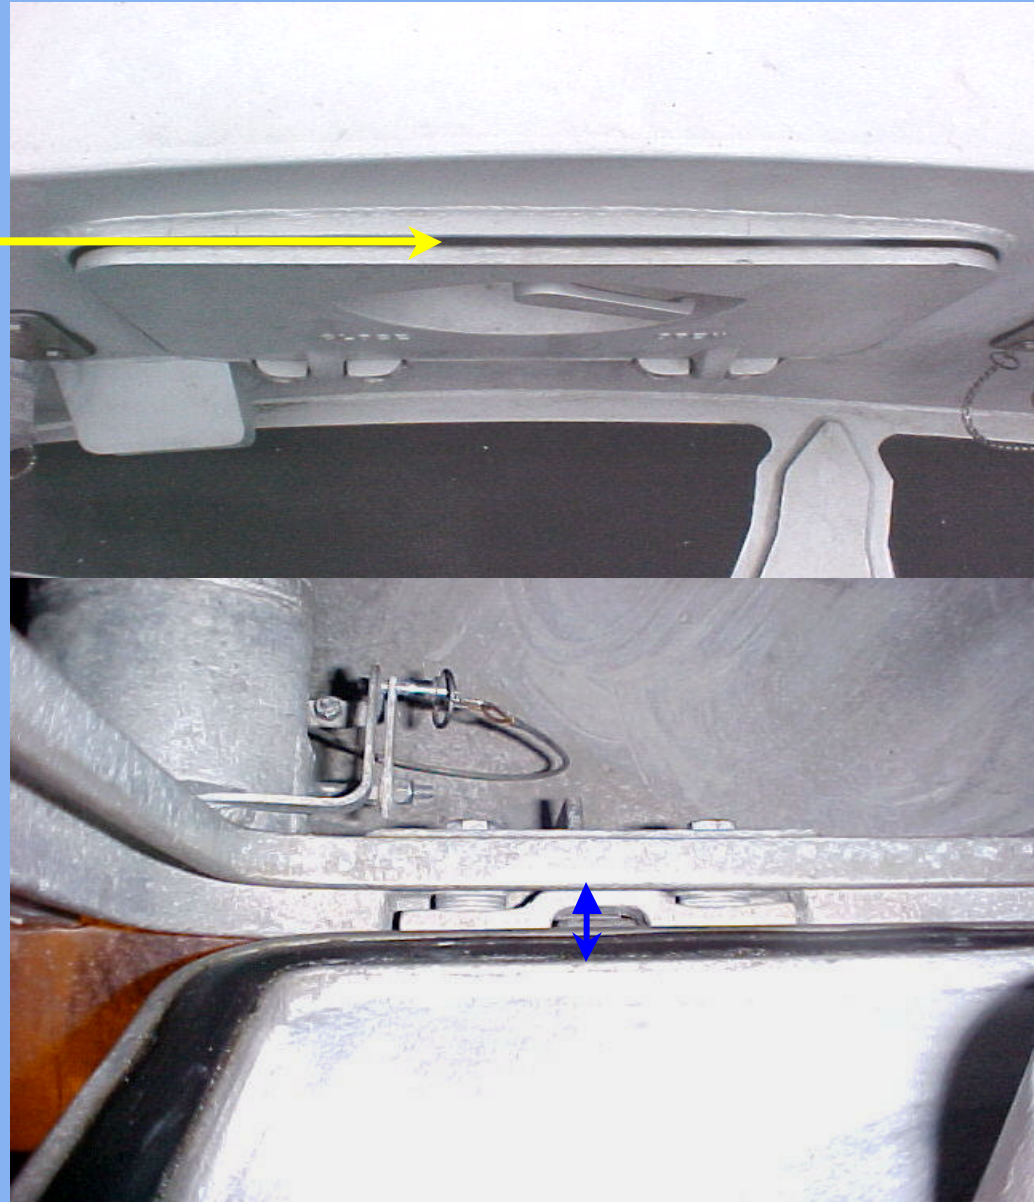
Aft Deck Buoyancy Box (Cont.)

- 3.) If this is not occurring, you will have to remove the four nuts on the hinges and check condition of Belleville washers. If the Belleville washers are flattened, they will need to be replaced. The washers should face opposite of each other with the one nearest the coaming facing with bevel out.

Note: The hinge bolts are threaded thru the coaming using thread inserts.

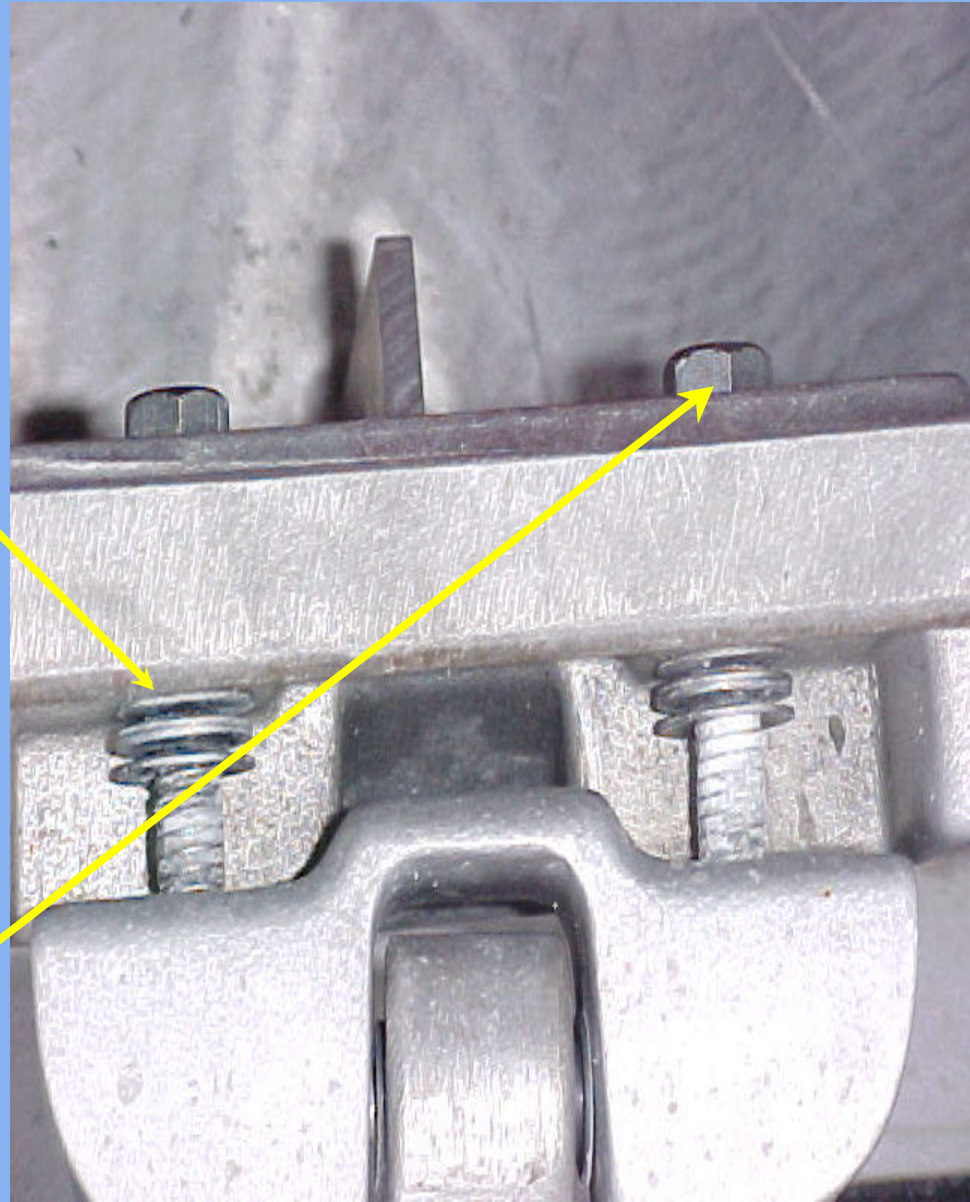
Aft Deck Buoyancy Box (Cont.)

- 5.) Check condition of gasket, if knife edge has caused a permanent indentation greater than 1/8" deep, replace gasket, recheck for seal.
- 6.) Check condition of knife-edge, replace as necessary.

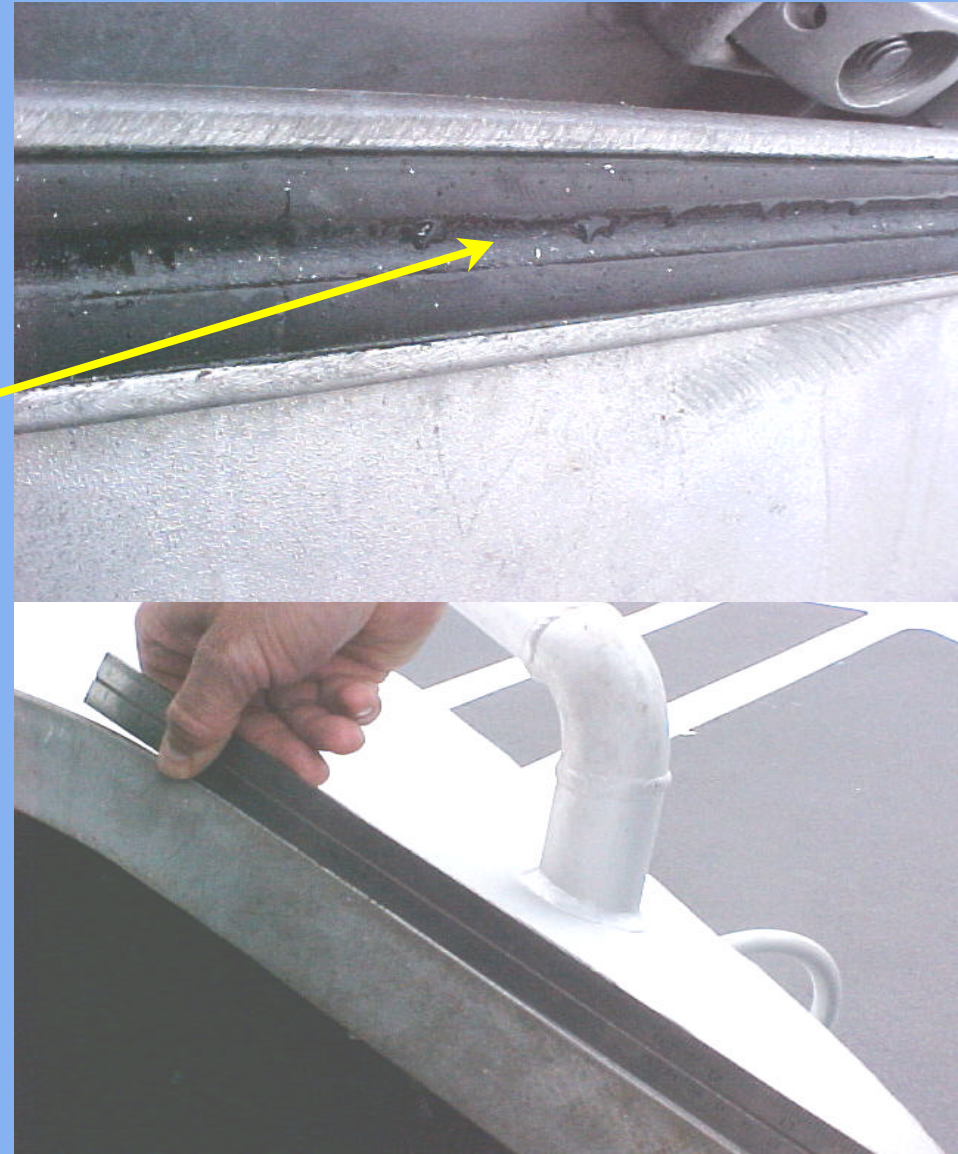
Watertight Door to Compartment

Failure to seal

- 1.) Check for loose Allen head cap screw on the end of the dog. “Do not over tighten set screw; they should be turned down just until the assembly makes light contact against the washer shims, otherwise the closure will be hard to operate”. Check for seal.

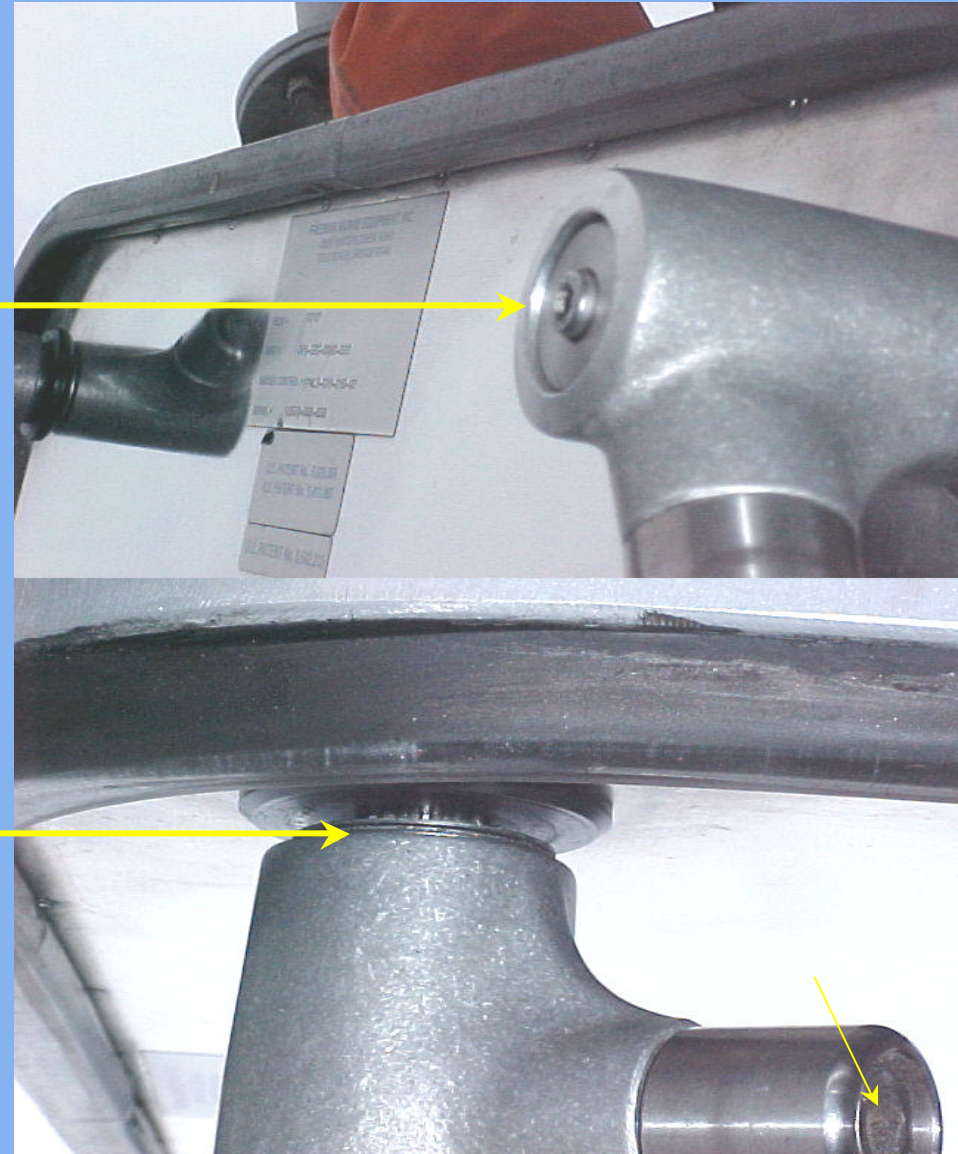
Watertight Door to Compartment (Cont.)

2.) Check for out of time dogs, dogs that do not reach the center of the striker plate when handle is turned from open to close. If out of time, remove dog and washer, note the number of shims removed, adjust dog so it lines up with the center of the striker plate and readjust using procedure in #1. Check for seal.

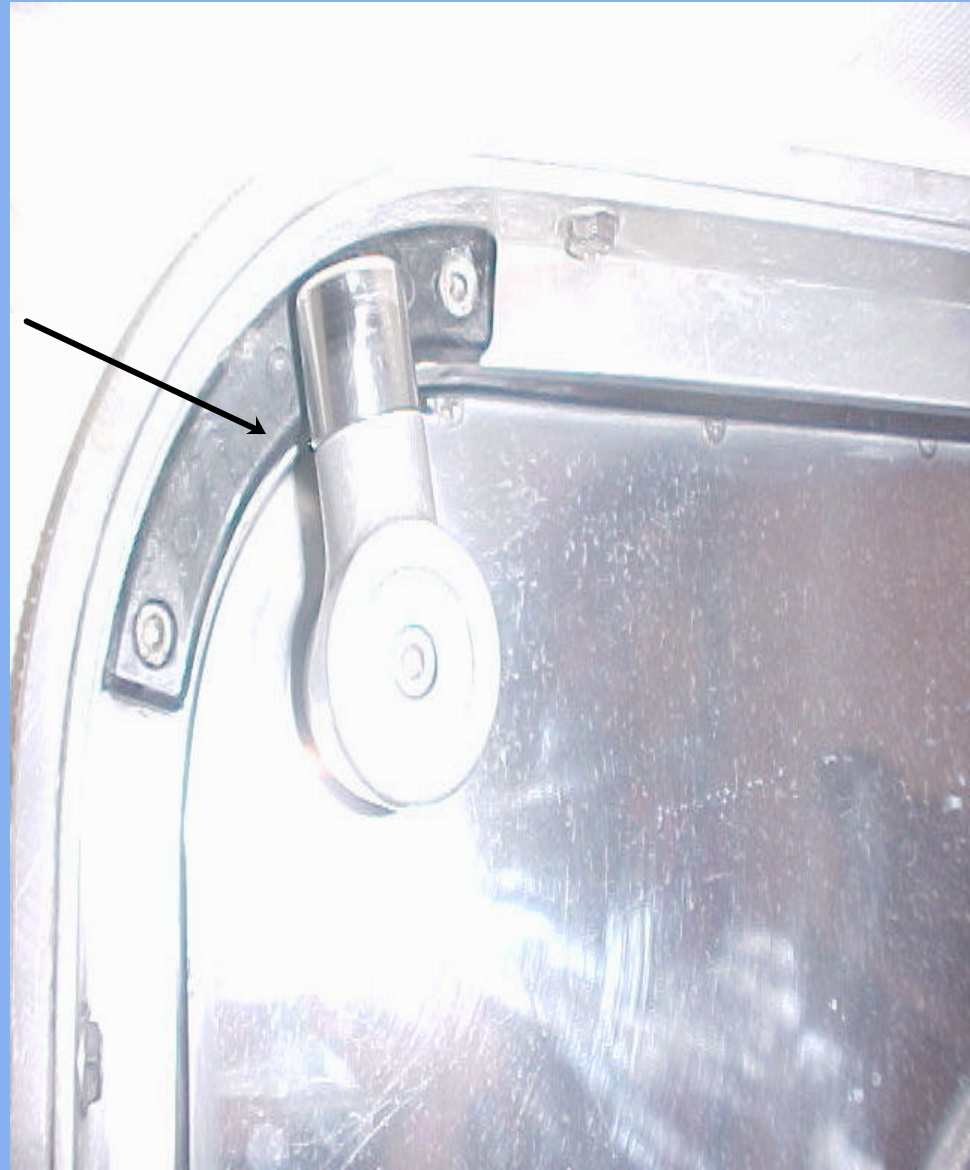
Watertight Door To Compartment (Cont.)

Note: On six dog doors, center dogs (Hinge side and handle) will stop just before making contact with dog stop.

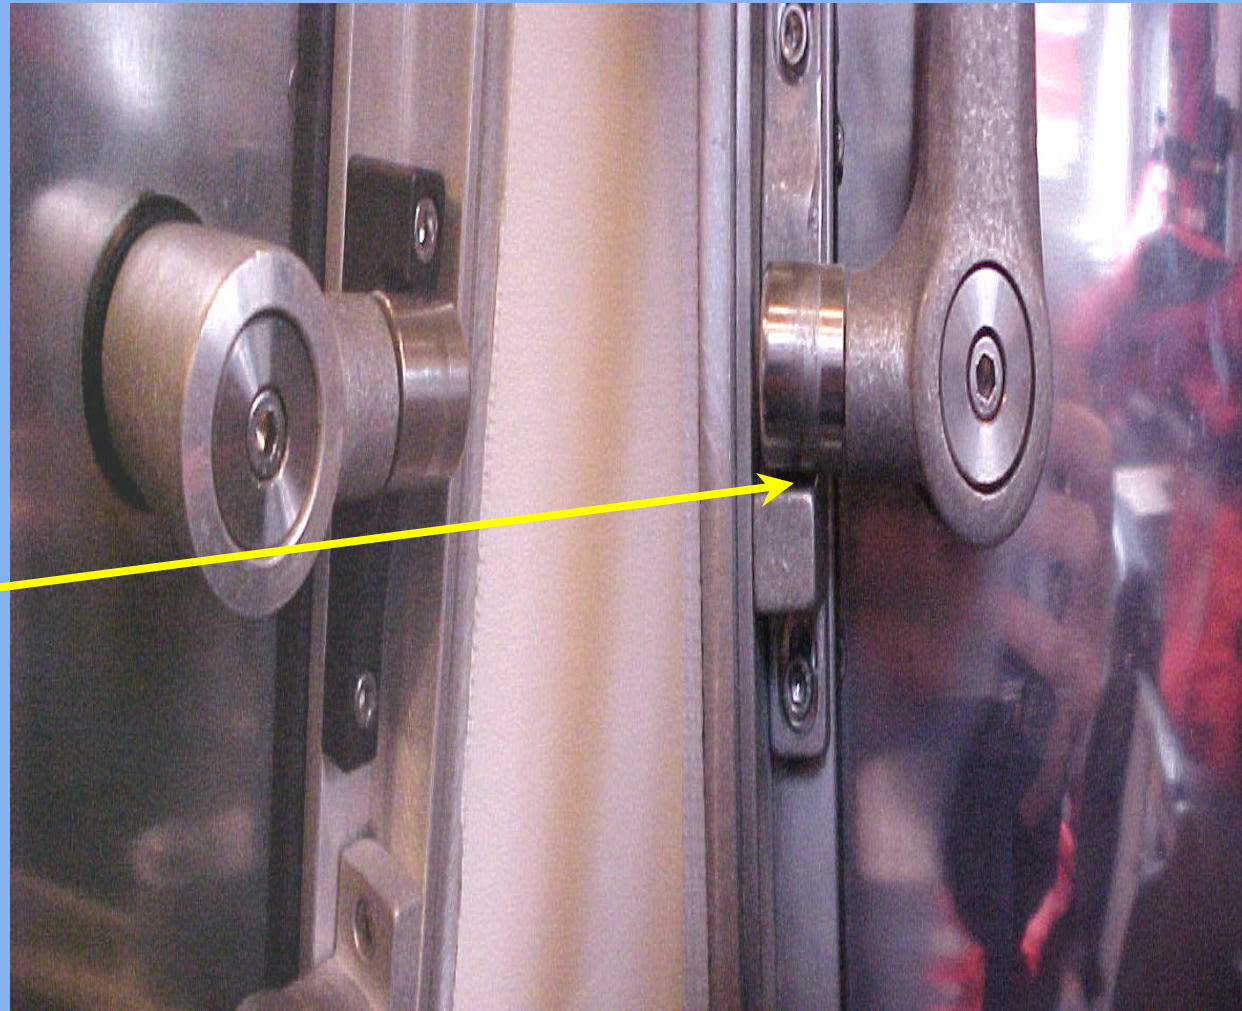
Watertight Door to Compartment (Cont.)

4.) Check closure stop for twist and warp, using the string test method described in the Freeman marine adjustment and maintenance instruction booklet.

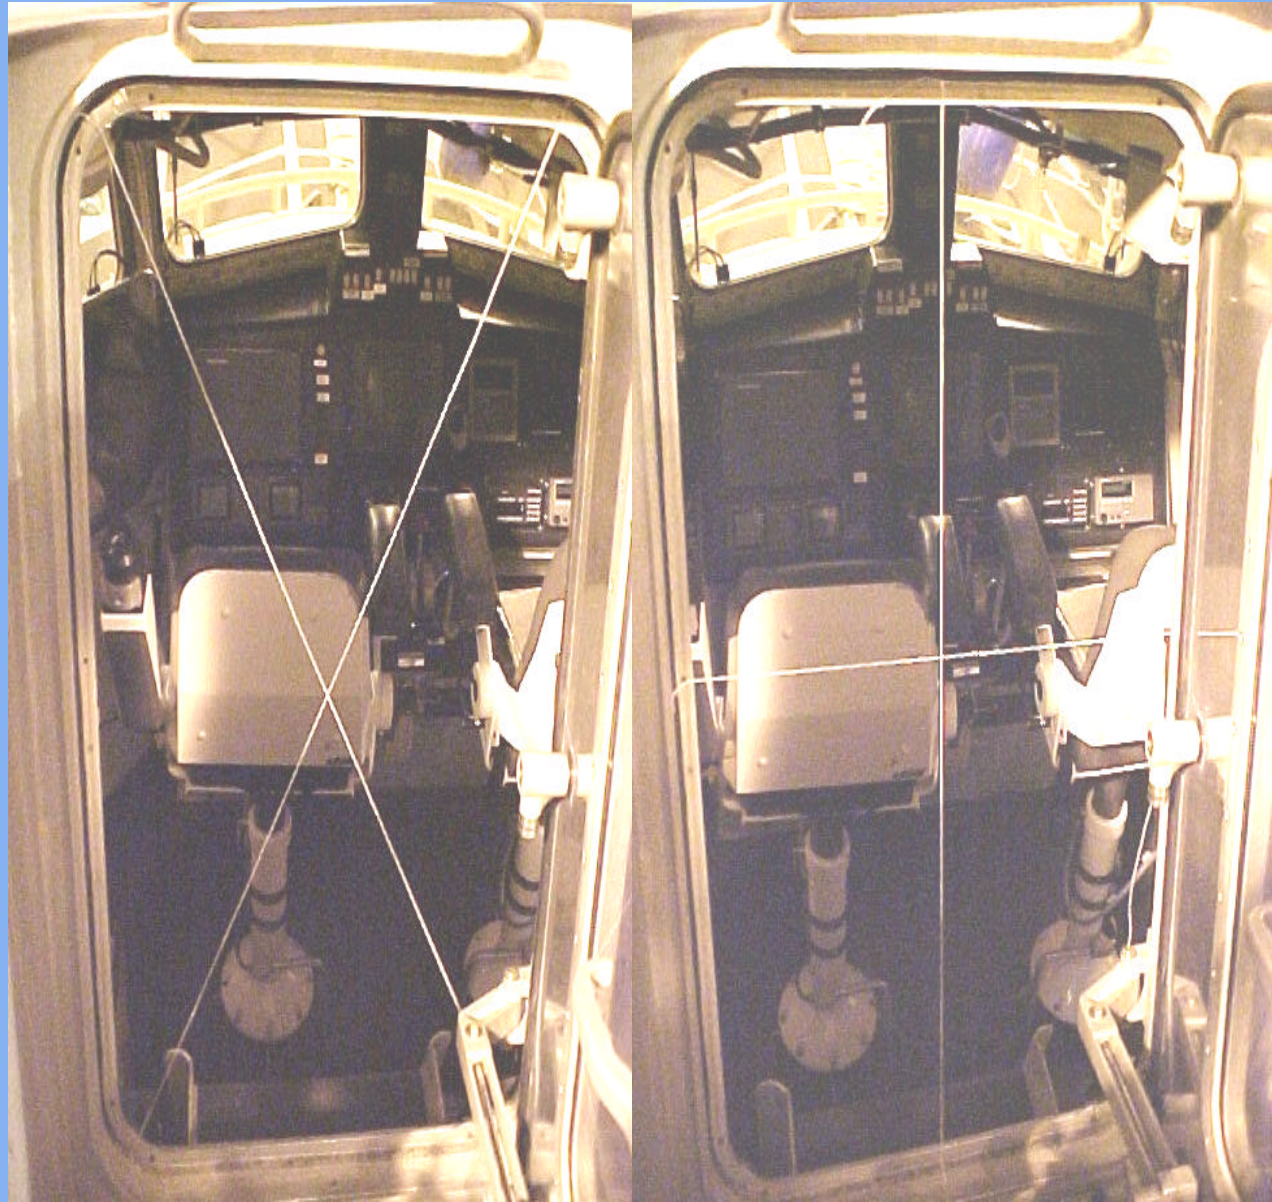
Watertight Door to Compartment (Cont.)

- 3.) The closure stop is adjustable by loosening bolts and move the closure stop in or out as needed. When performing this step, loosen all the bolts and slide the doorstop in, close the door and move the stop up to the gasket on the door. Ensure it's even around the whole stop and tighten the bolts alternating between sides. Adjust dogs as per #1.

Note: Adjustment of the closure stop can cause the sealant to tear and will require resealing

“Sikaflex or other quality marine adhesive sealant” is recommended.
